PERFORMANCE OF THIN BONDED CONCRETE OVERLAYS IN ILLINOIS

PHYSICAL RESEARCH REPORT NO. 134
MARCH 2000

Illinois Department of Transportation

Interim Report

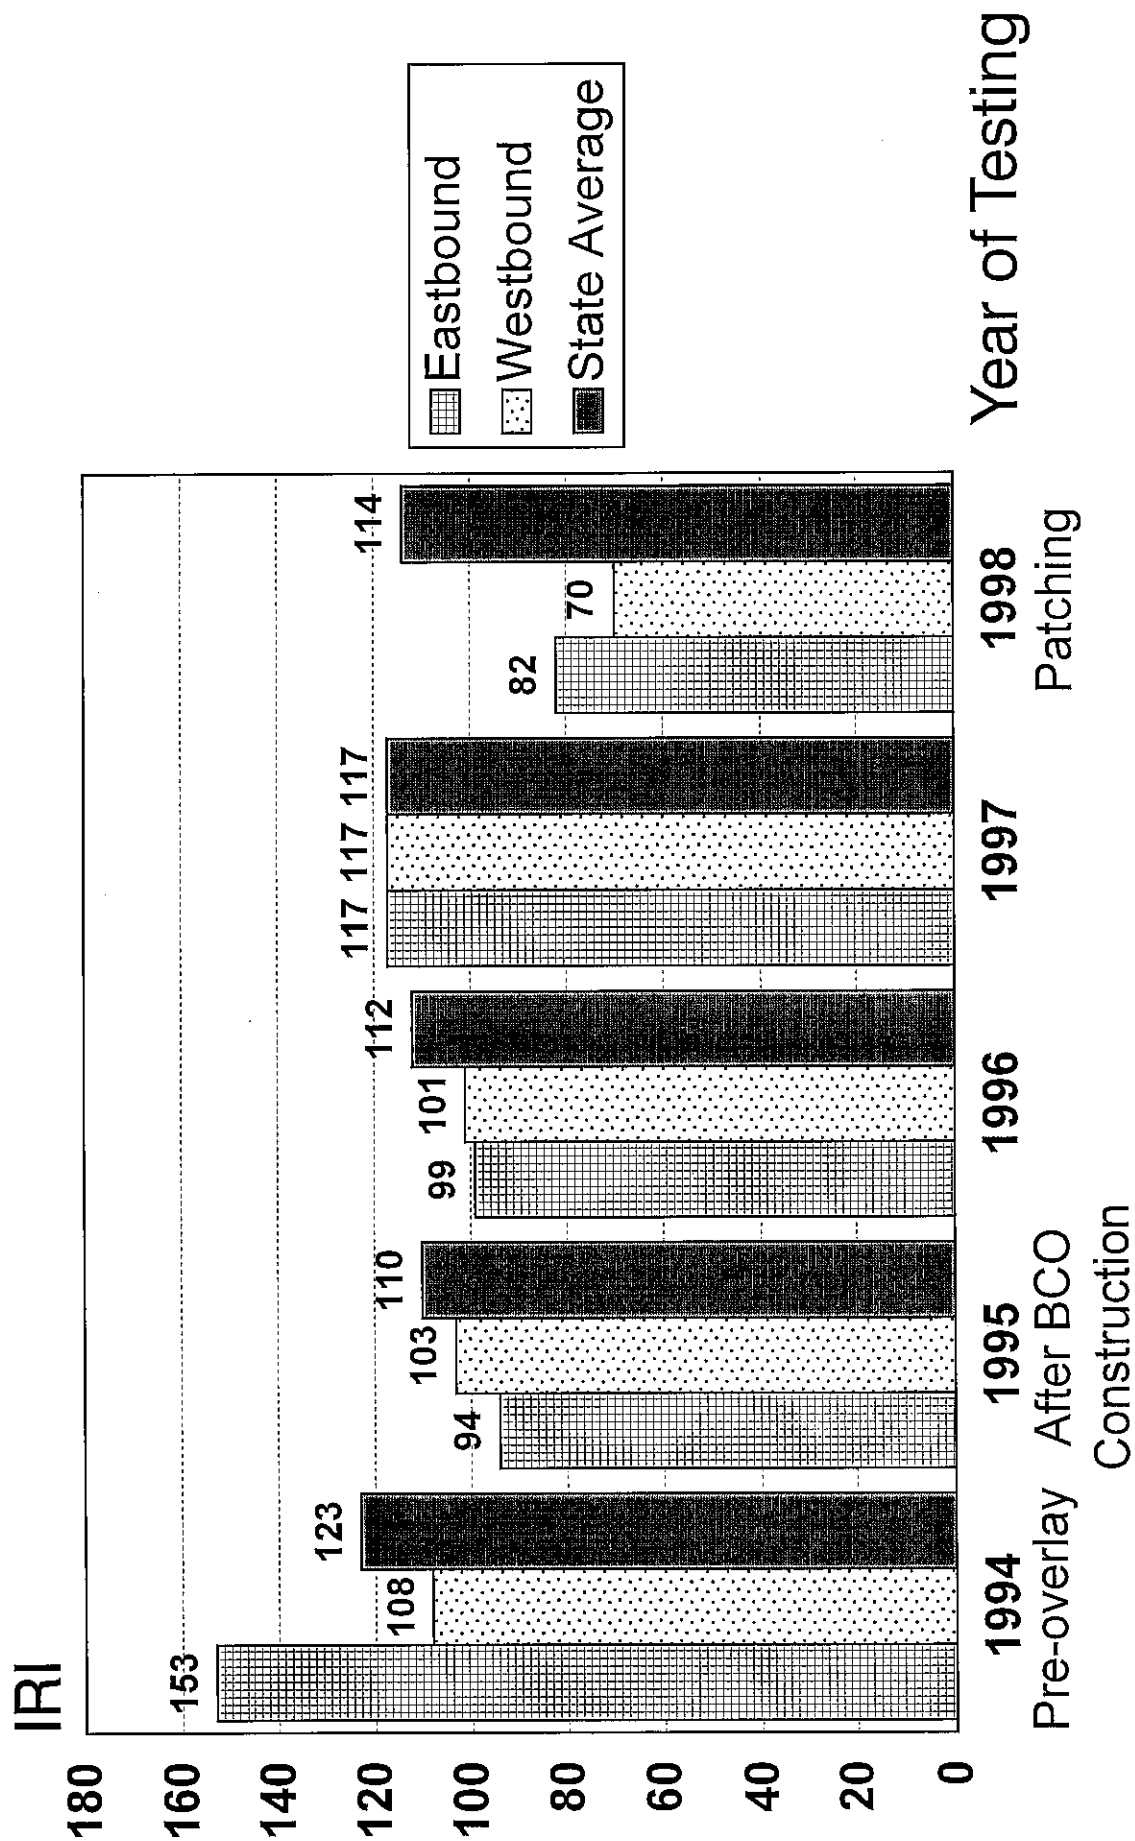
Figure 1

International Roughness Index (IRI) values decreased after construction of the I-80 and I-88 overlays. The I-80 average IRI values gradually increased in the years after construction but decreased significantly after sections of the I-80 BCO were patched in

I-80 Average IRI

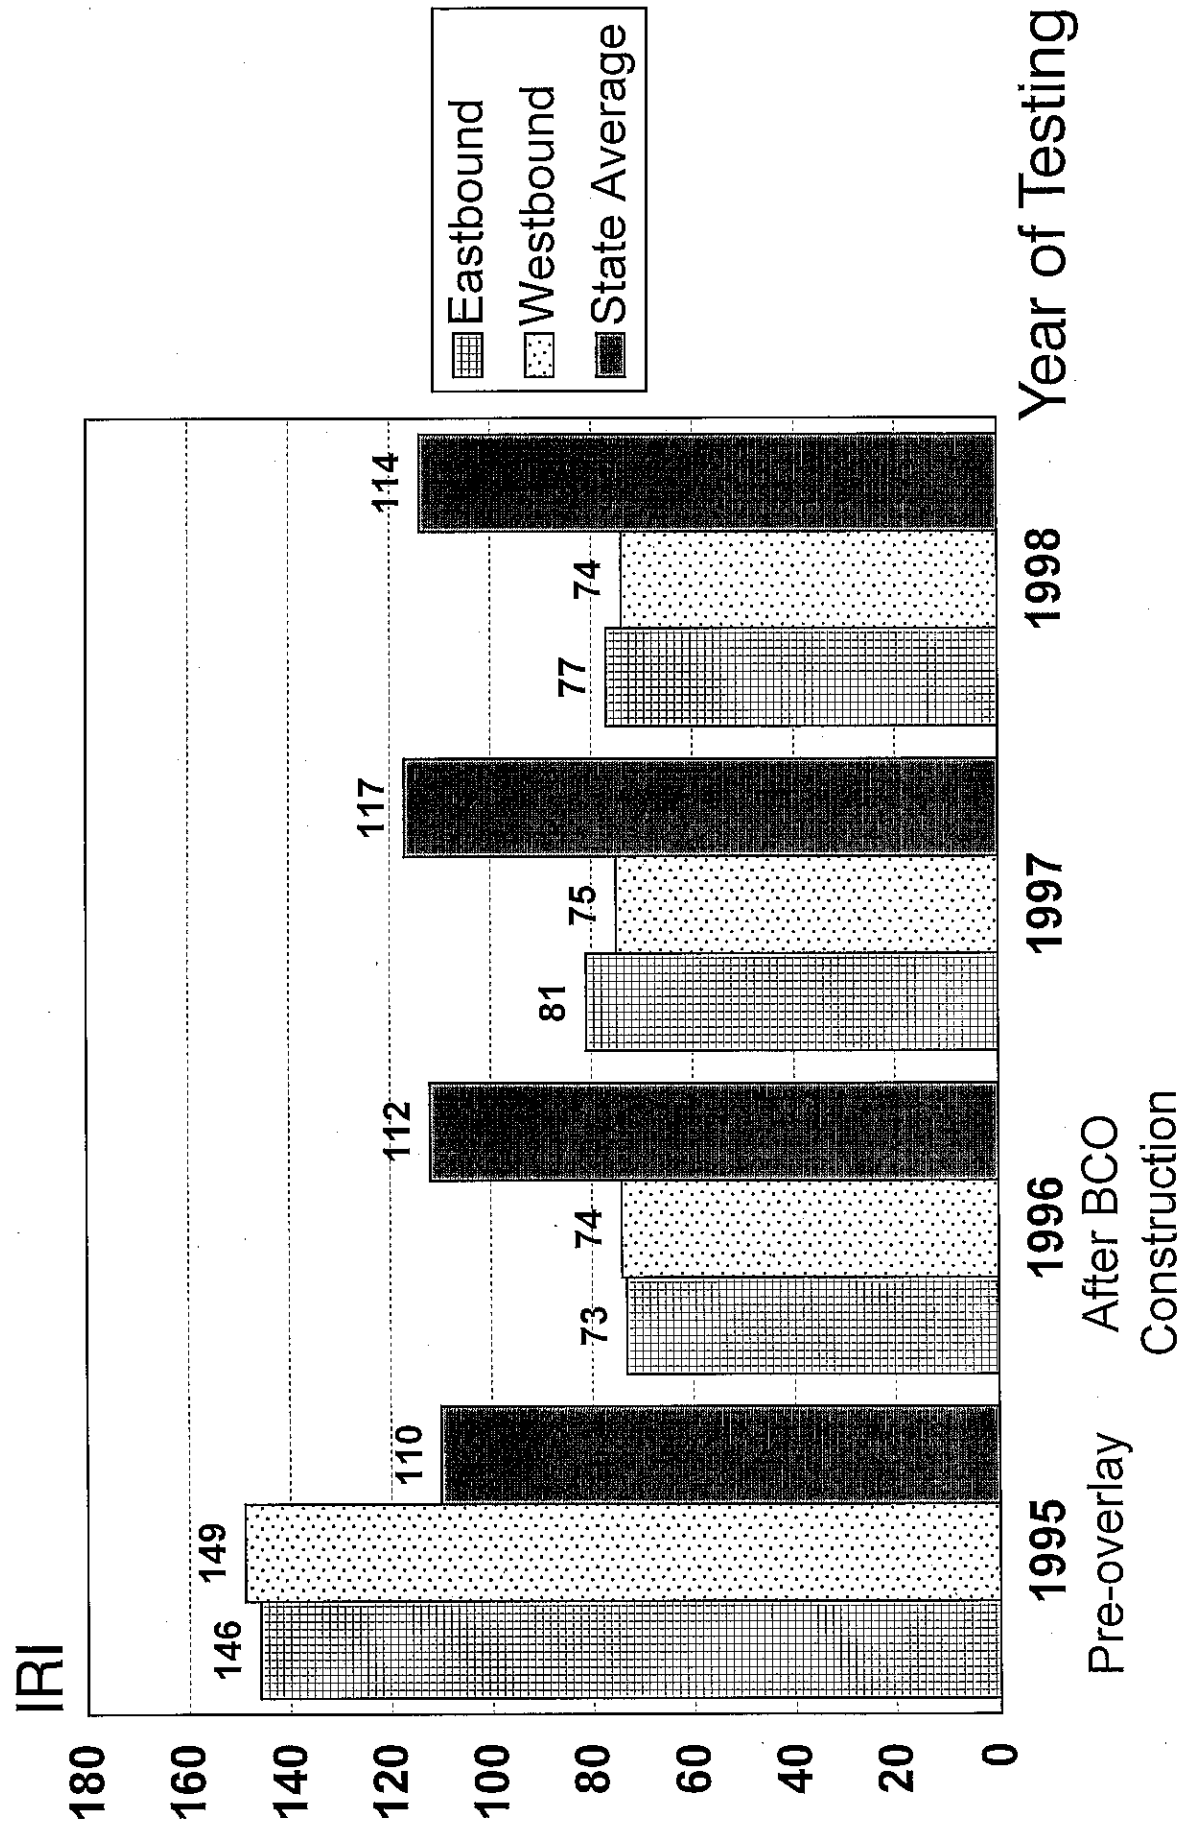
Figure 2

1998. The I-88 average IRI values have not fluctuated significantly since construction of the BCO in 1996.

I-88 Average IRI

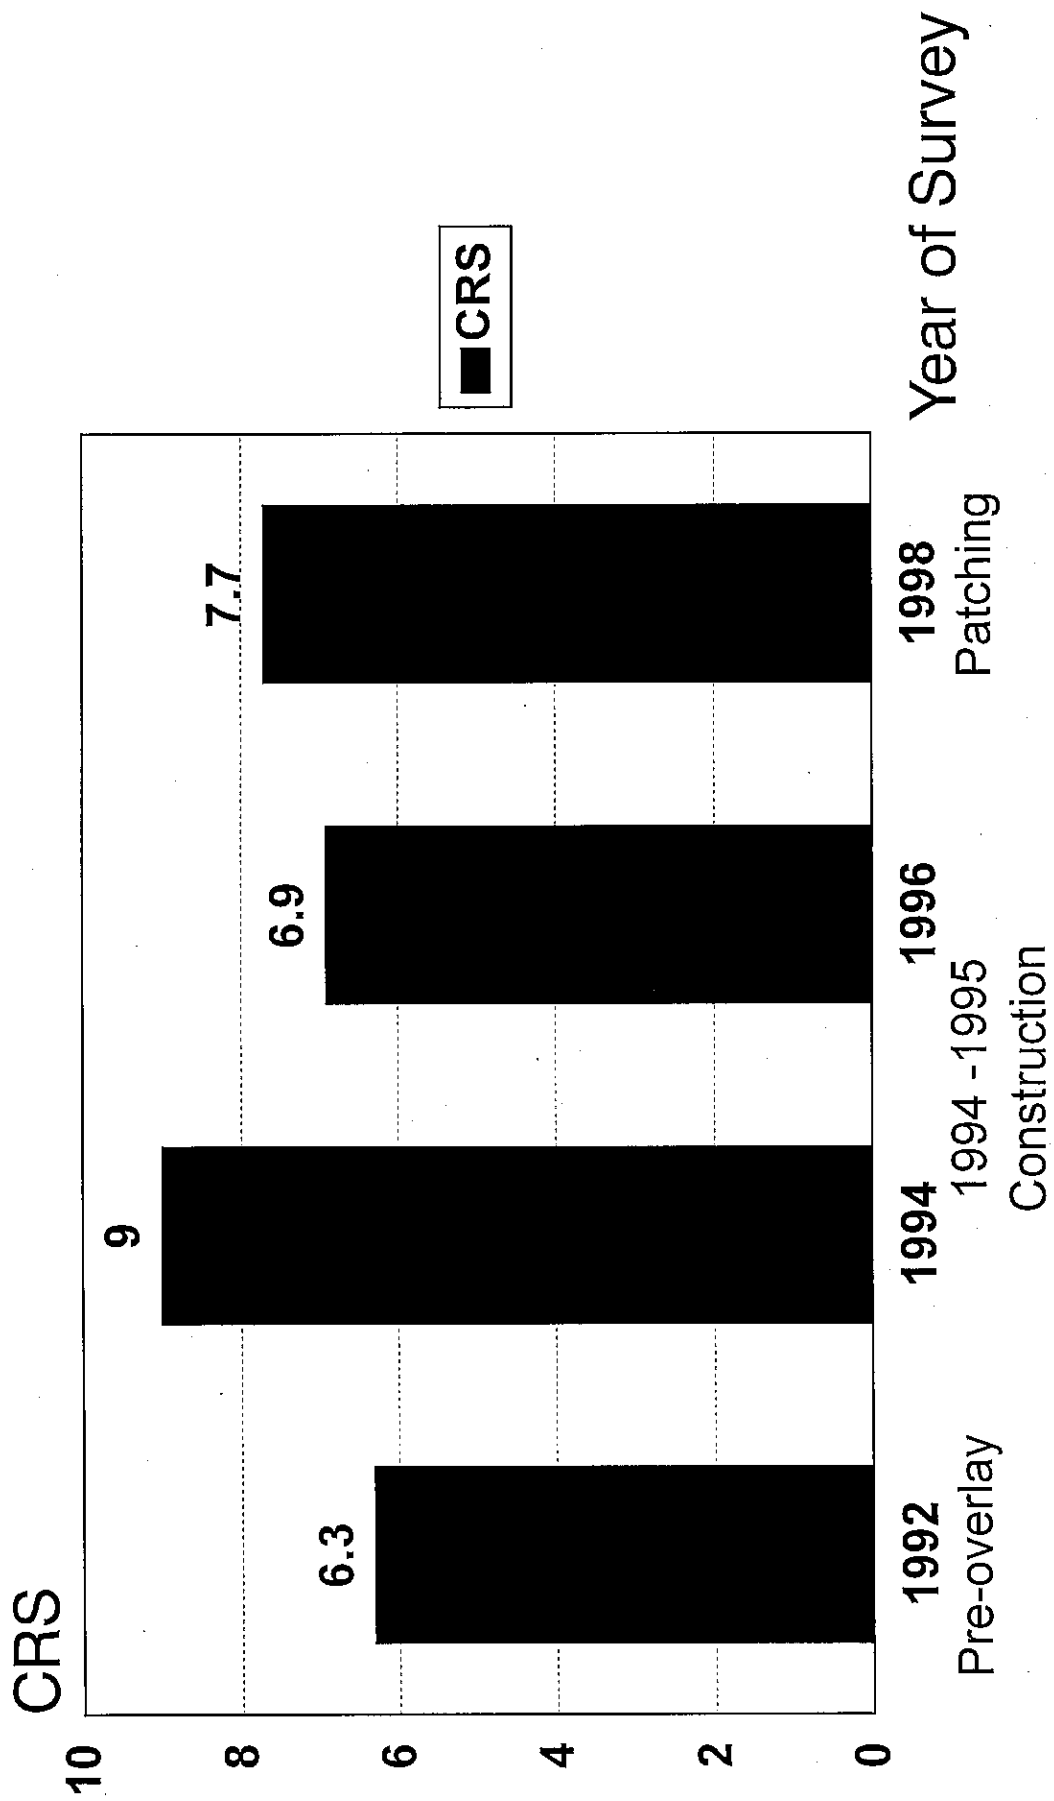
Figure 3

Even though the I-80 BCO was assigned a CRS of 9.0 in 1994, the year of construction, it quickly decreased to 6.9 in 1996, just two years after construction. A 1998 CRS value of 7.7, the most recent CRS value available for I-80, indicates that the patching completed in 1998 significantly improved the condition of the I-80 BCO. The 1994 CRS value of 7.8, assigned to I-88 before the BCO, indicates that the pavement was already in excellent condition. Furthermore, the 1998 CRS value for I-88 of 8.2 verifies that the BCO is still in excellent condition.

The 1992 CRS is the last available for I-80 that represents the condition of the pavement before the BCO. Since I-80 was planned for rehabilitation in 1994, it was assigned a CRS value of 9.0 in 1994. However, the actual 1994 CRS value of 9.0 does not accurately reflect the condition of the pavement just before the BCO was placed. As mentioned previously, the CRS assigned to I-80 in 1992 was a 6.3. By the time of the construction of the I-80 BCO in 1994 - 1995, the CRS value obviously decreased. With appropriate deduct values subtracted from the 1992 CRS value, an estimated CRS value for 1994 is 6.1. A CRS of 6.1 is at the bottom of the scale for a pavement considered to be in "good" condition.

I-80 CRS

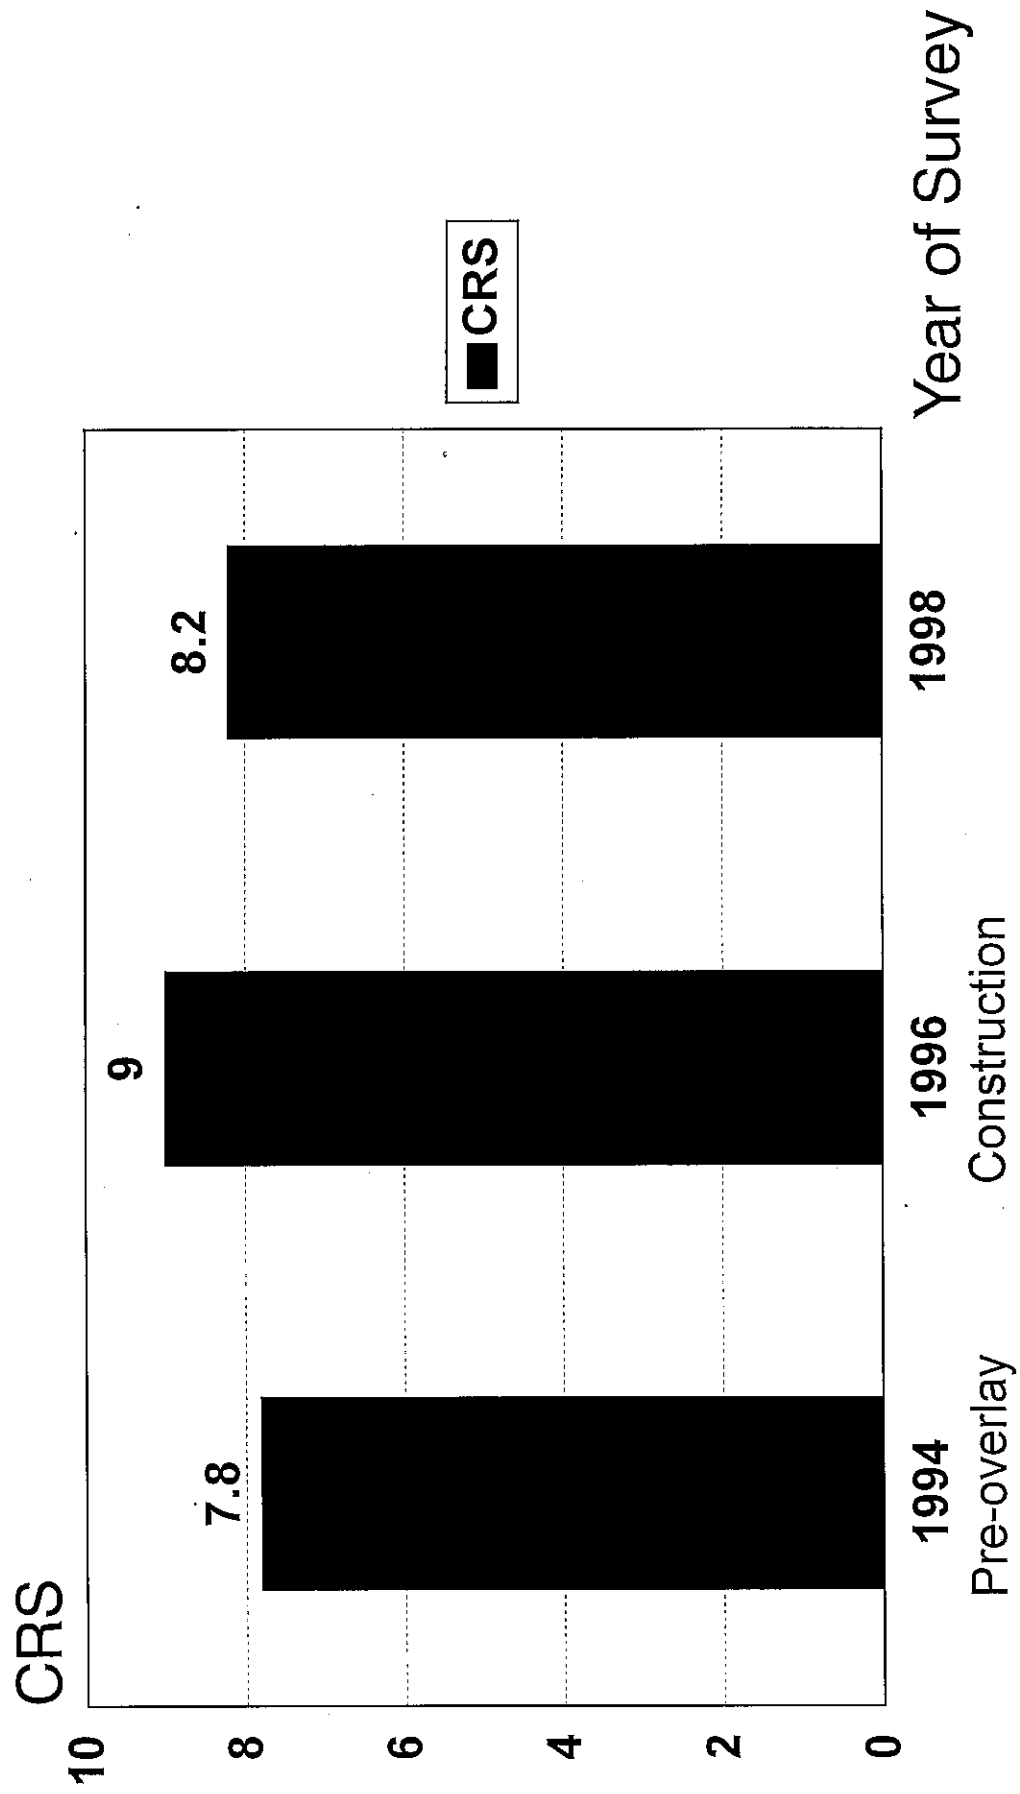
Figure 4

The CRS value of 7.8 assigned to I-88 in 1994 (before the BCO) indicates that the pavement was already in excellent condition. Like I-80, I-88 was assigned a 9.0 in 1996 (the year the BCO was constructed). With appropriate deduct values subtracted from the 1994 CRS value, an estimated CRS value for 1996 is 7.6 (an "excellent" rating). In 1998, two years after the construction of the overlay, I-88 was assigned a CRS value of 8.2 (an "excellent" rating).

I-88 CRS
